PINE RUN DAM, BUCKS COUNTY
PENNSYLVANIA

NDS I.D. NO. PA 00808
DER I.D. NO. 9-170
SCS PA 616

PHASE I INSPECTION REPORT
NATIONAL DAM INSPECTION PROGRAM

WOODWARD-CLYDE CONSULTANTS
5120 Butler Pike
Plymouth Meeting, Pennsylvania 19462

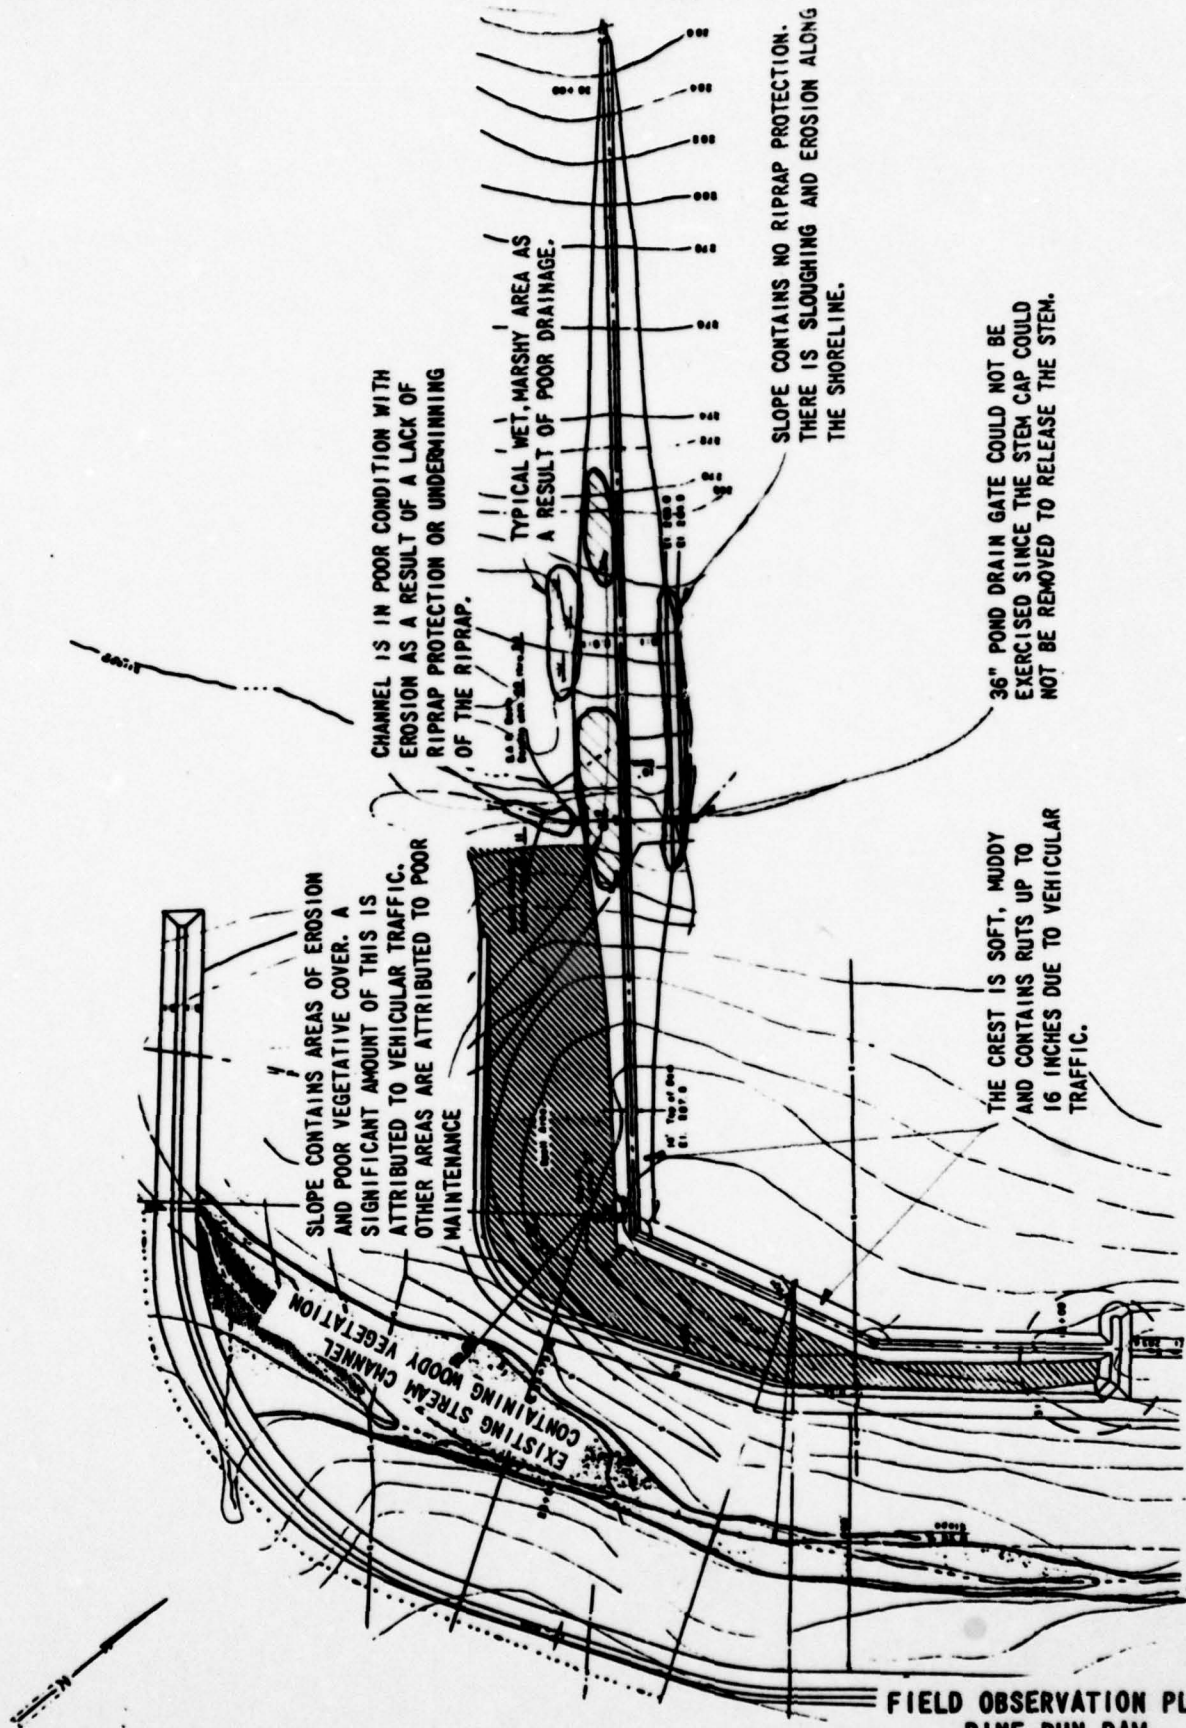
Sheet 5 of 11

VISUAL EXAMINATION OF	OBSERVATIONS	REMARKS OR RECOMMENDATIONS
SURFACE CRACKS	The embankment crest is in poor condition containing ruts up to 14 to 16 inches in depth with areas of ponded water and mud.	
UPSTREAM SLOPE	The vegetative cover is poor and has "patchy" areas with scattered erosion all along the slope. Erosion has usually started in areas of "trail-bike" traffic.	
UNUSUAL MOVEMENT OR CRACKING AT OR BEYOND THE TOE	None observed.	
SLOUGHING OR EROSION OF EMBANKMENT AND ABUTMENT SLOPES	Slopes contain many areas of erosion and general deterioration of vegetative cover attributed to vehicular traffic on the slope and, to some extent, attributed to the lack of maintenance.	
VERTICAL AND HORIZONTAL ALIGNMENT OF THE CREST	The vertical and horizontal alignment was checked and found to be satisfactory except for the ruts in the road.	
RIPRAP FAILURES	No riprap and upstream slope is in poor condition with erosion along shoreline.
